## VIBETEC INC.

14<sup>th</sup> November 2003

Ref: 15MW Hydro Generator Sets #1 and 2 at your Pingston location.  
 Generator #1: serial # 167955-1 / Generator #2: serial # 167955-2  
 Dave,

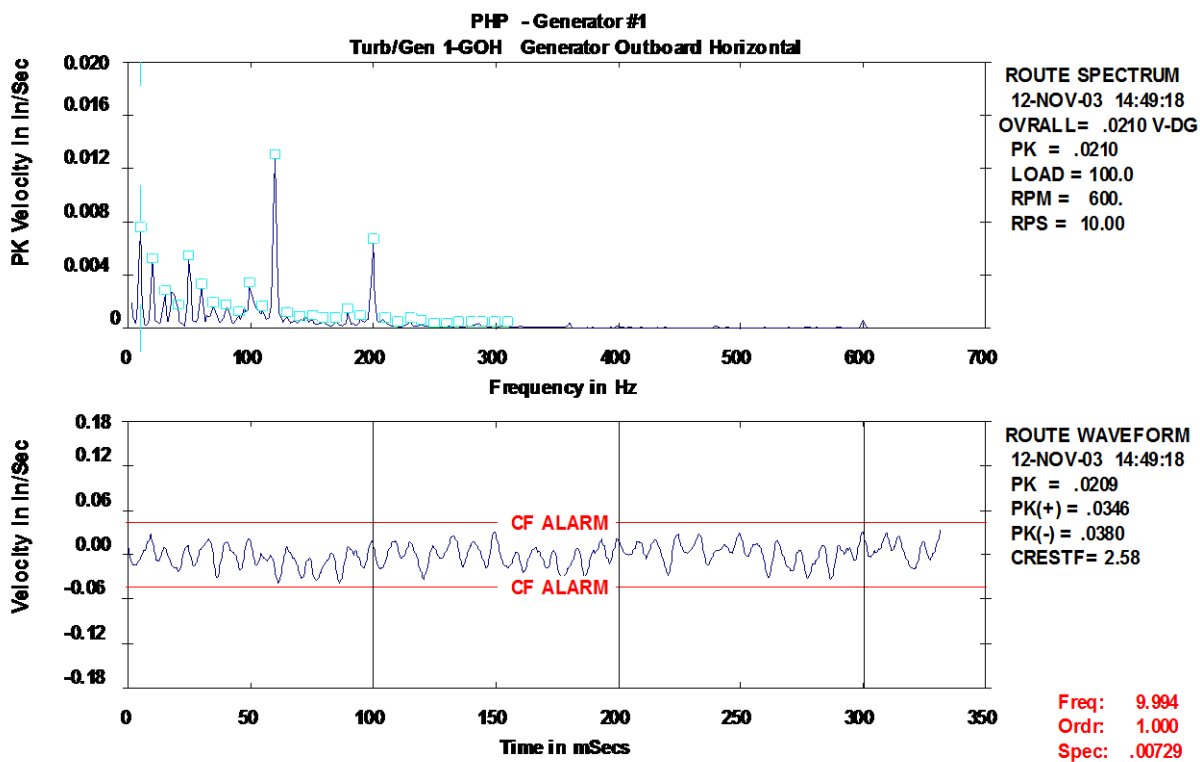
No problems apparent at these locations. The high peaks in both spectral charts are at 12 X RPM and are probably inherent pole pass frequencies.

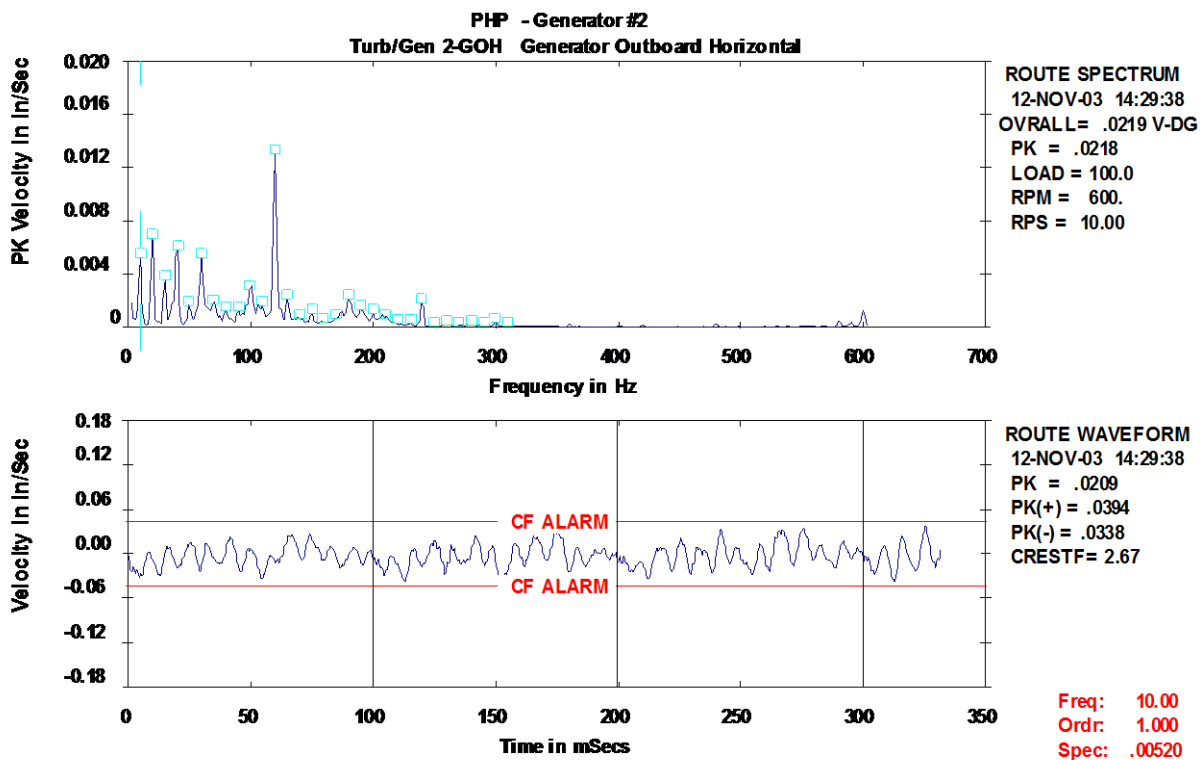
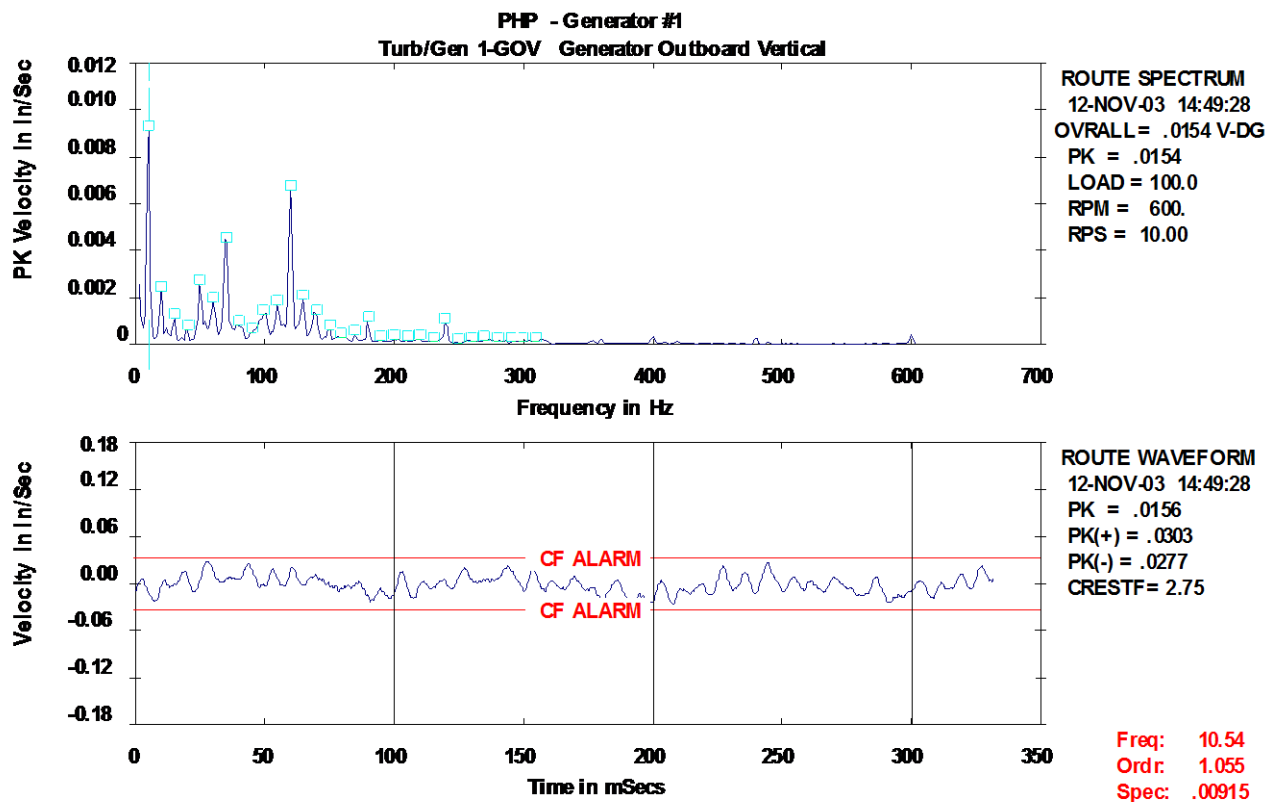
No problems at these locations. The spectral peaks are normal inherent frequencies (machine noise).

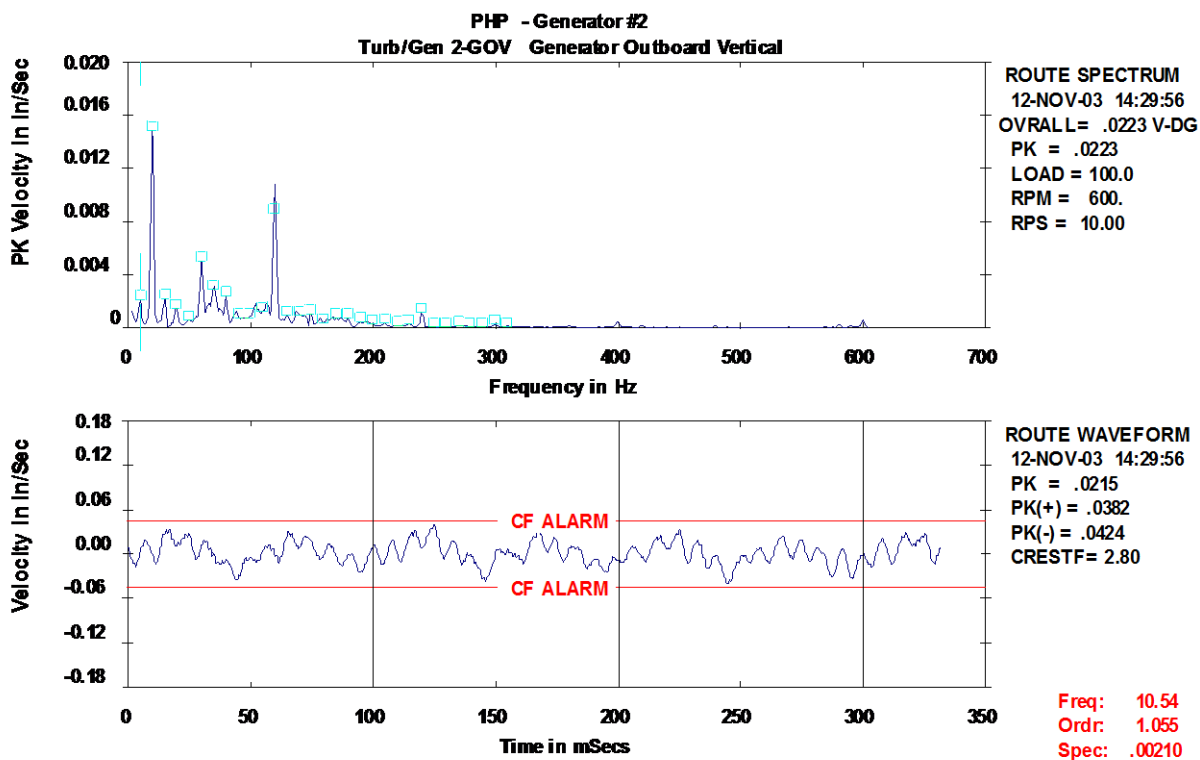
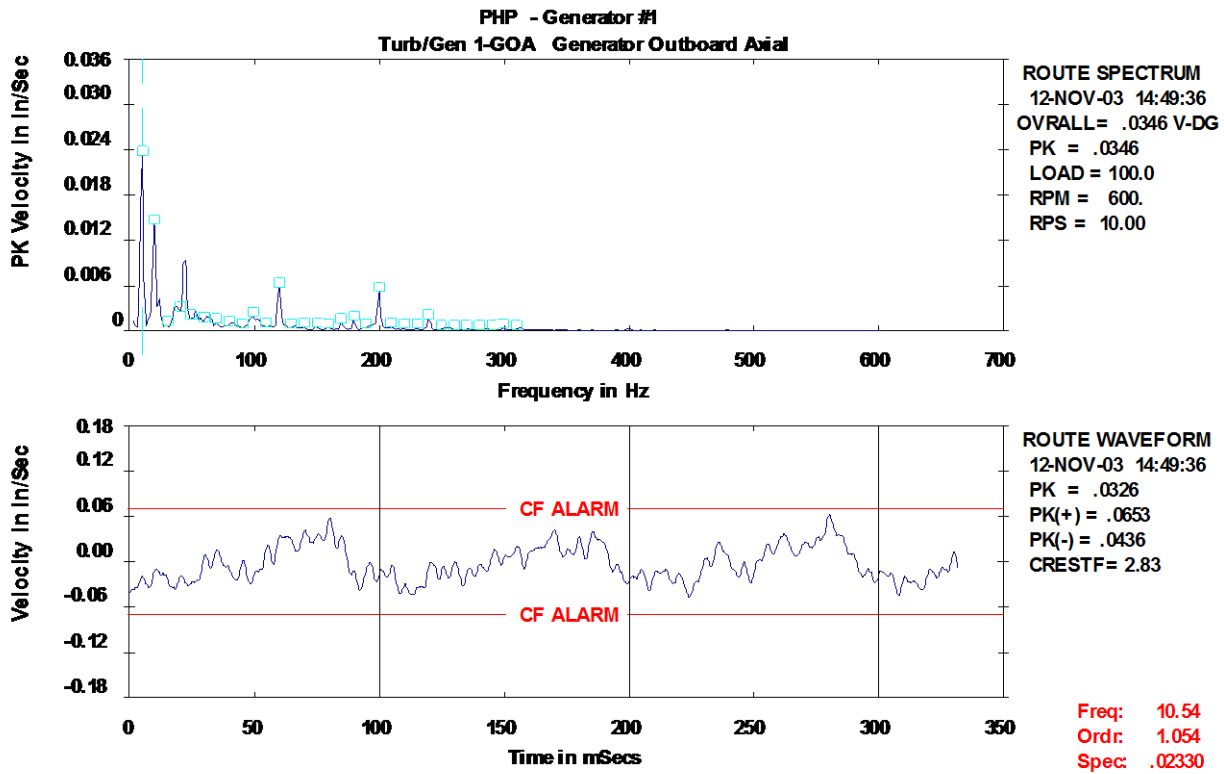
On generator # 2 the high peak is at twice the operating rpm and is probably caused by slight coupling misalignment.

The highest vibration amplitude recorded during my survey was on #2 generator in the axial position, to ensure longevity of the machine I think that it would be prudent to check the coupling alignment with the aid of a laser alignment system.

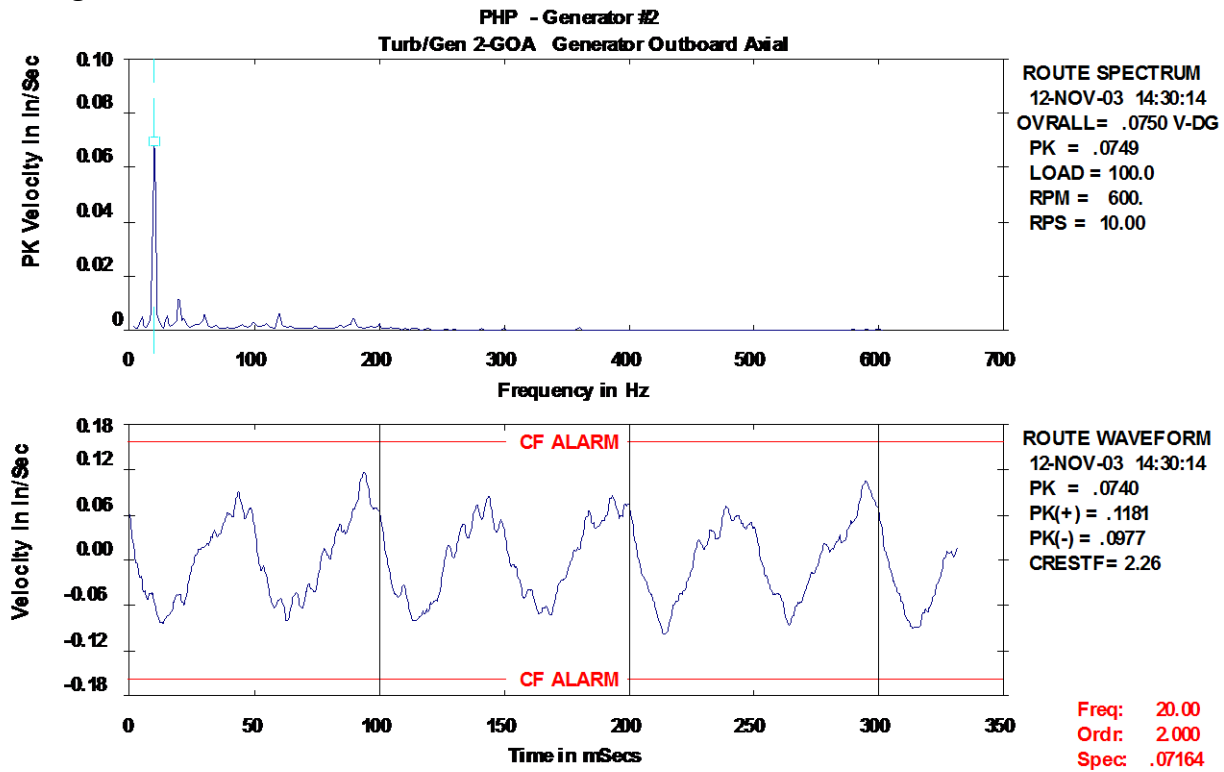
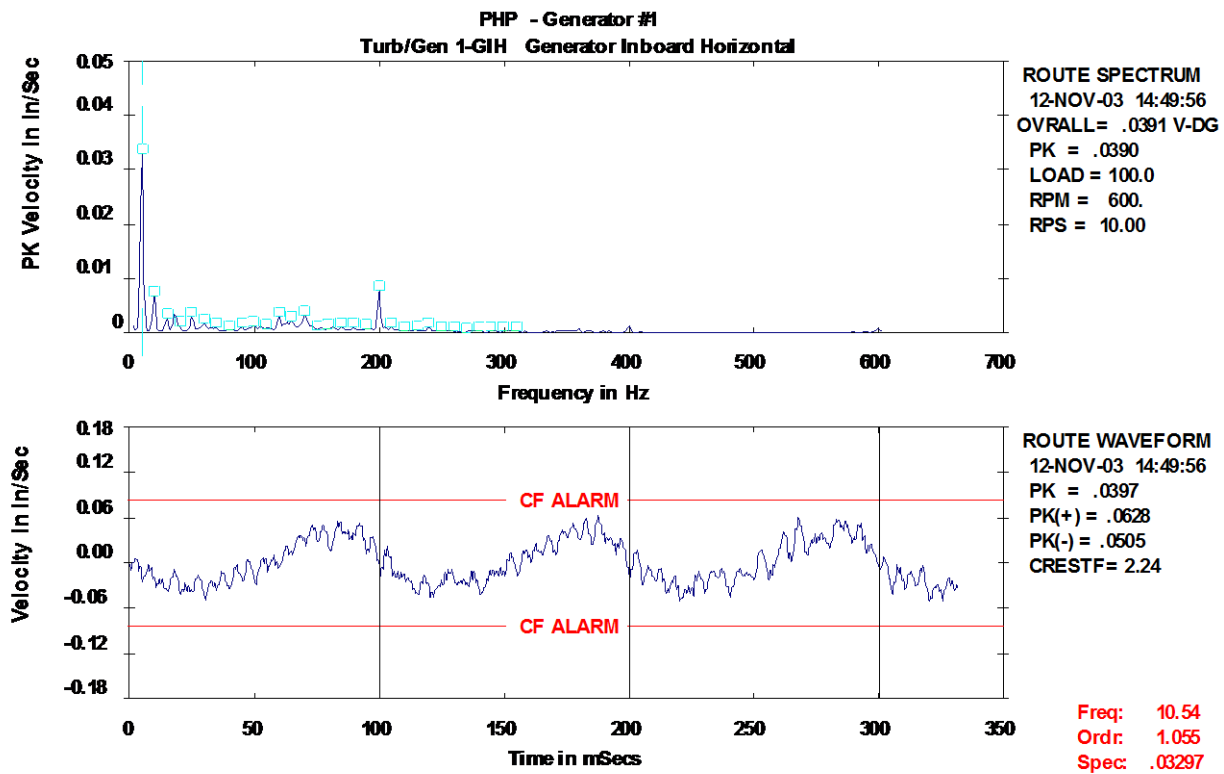
Generator #1 rotor appears to be slightly unbalanced, generator #2 has a relatively high 2 X amplitude which again indicates a misaligned coupling.

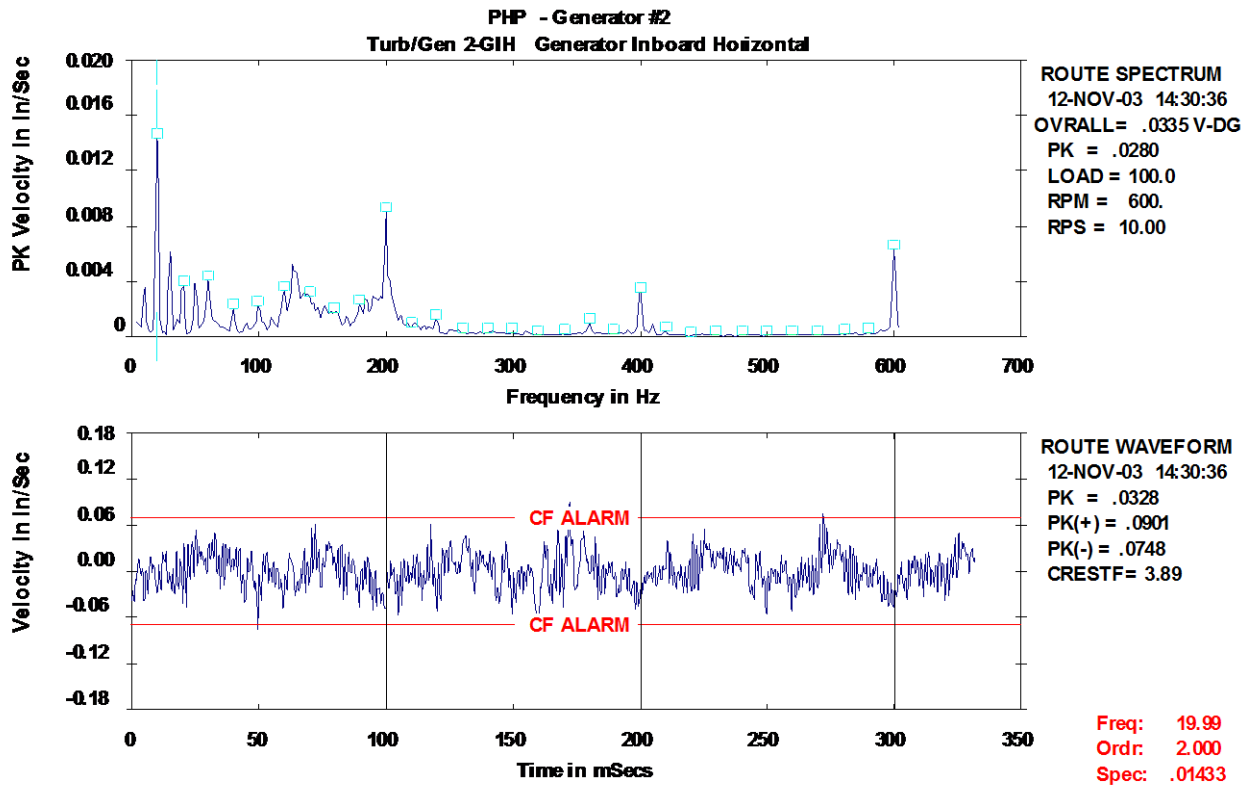
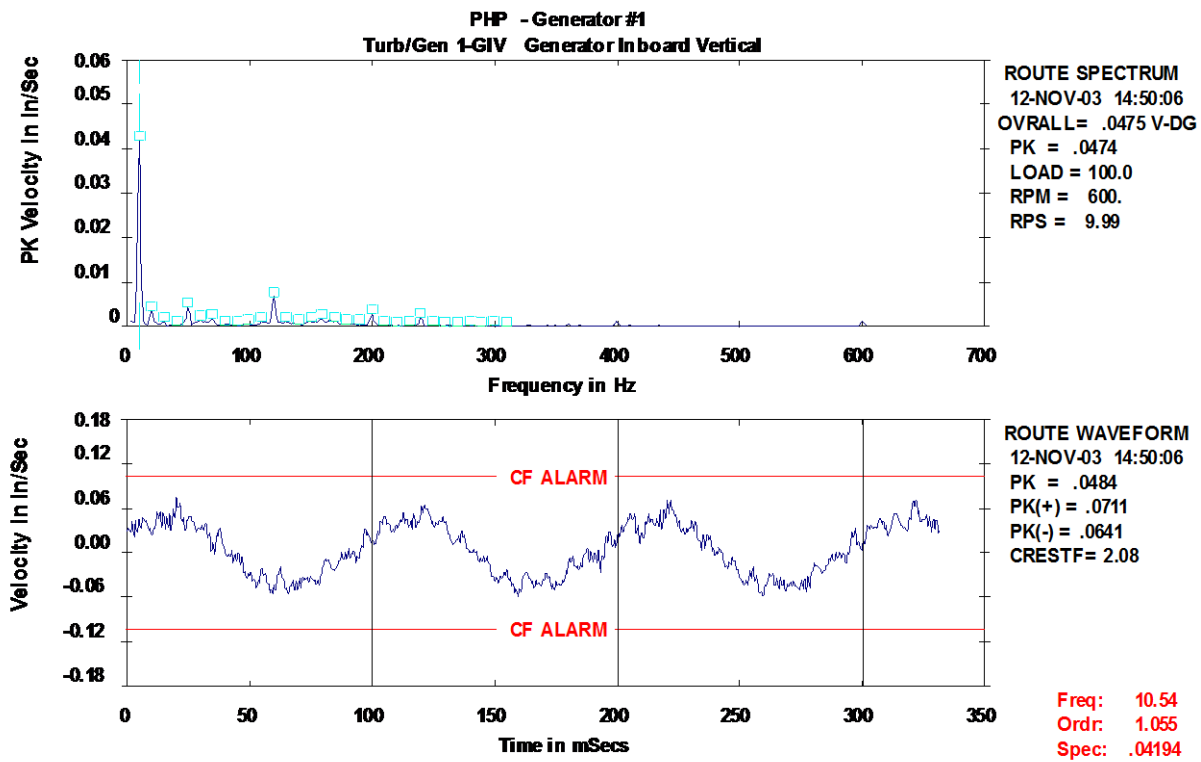
Same issues as found in the above horizontal measurements are in evidence on both generators in the vertical plane.

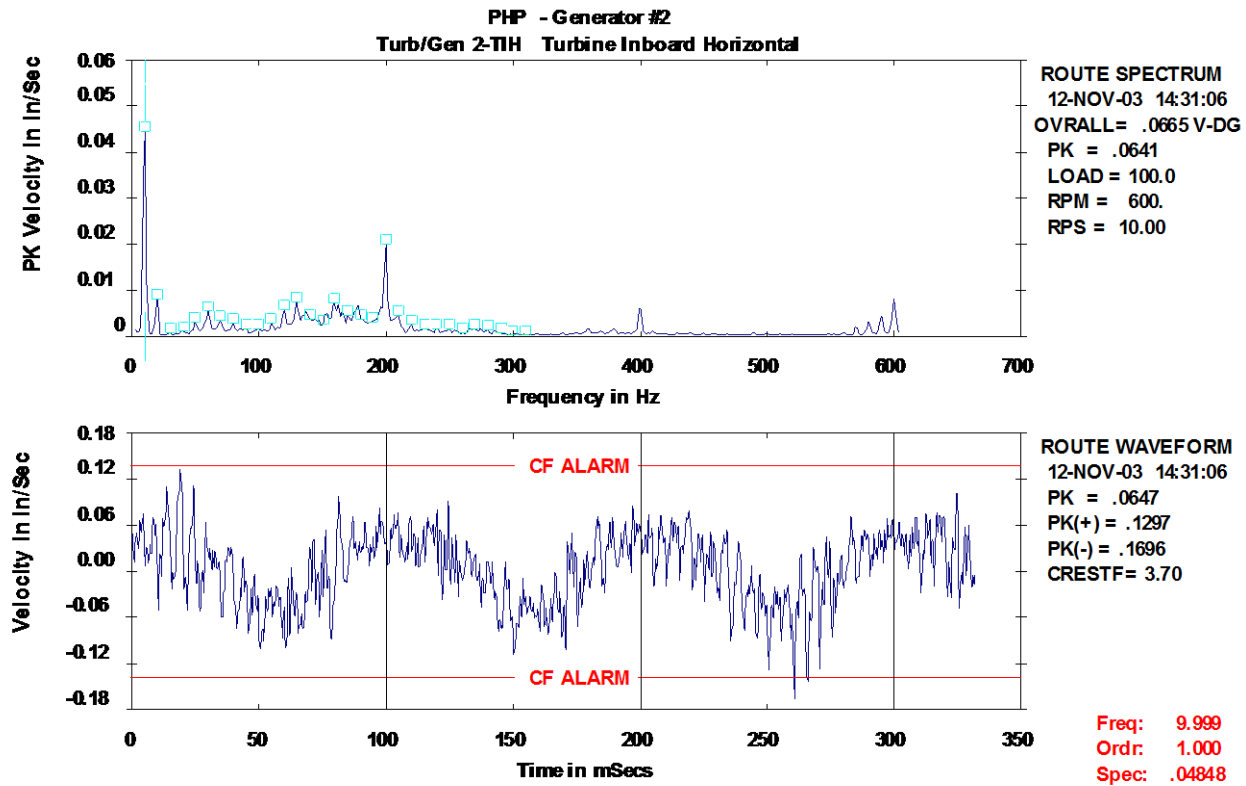
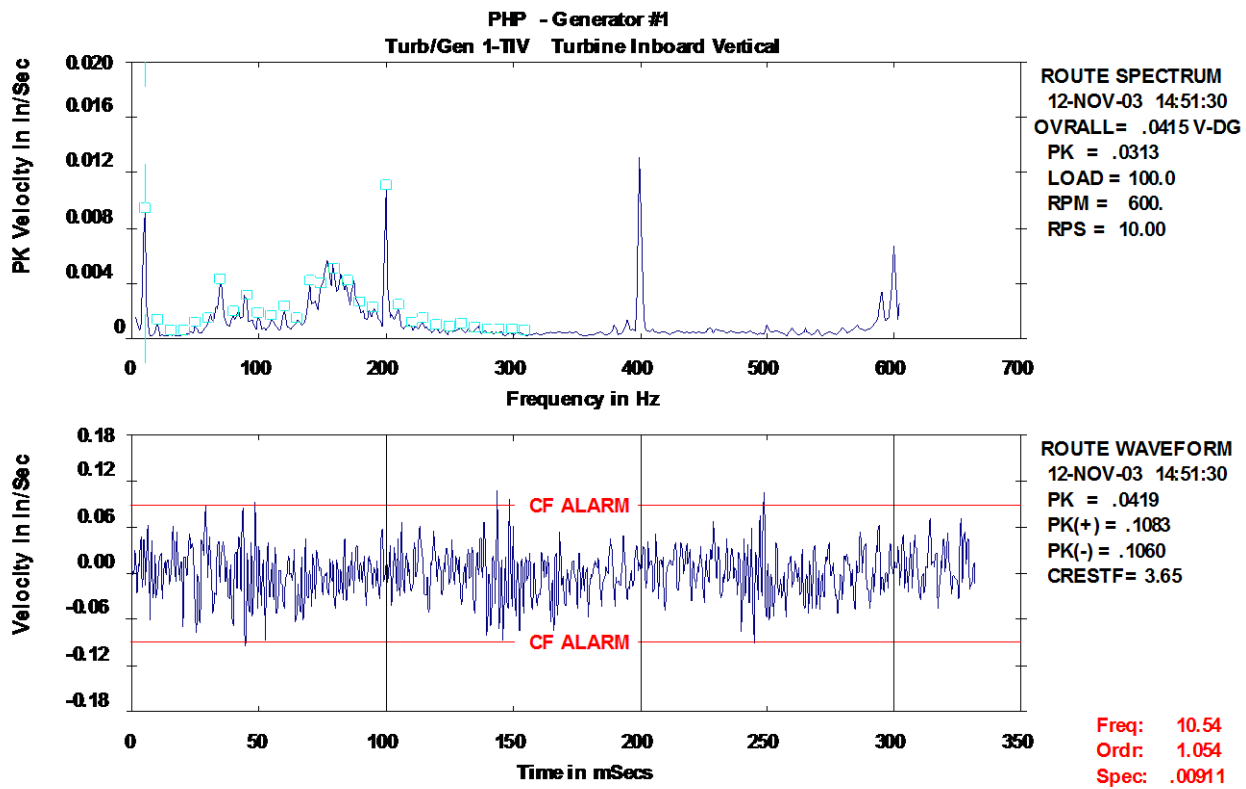
No problems apparent at these locations. The unbalance on turbine #2 noted in the horizontal plane is not as apparent in the vertical axis because of the relative stiffness in the vertical plane.

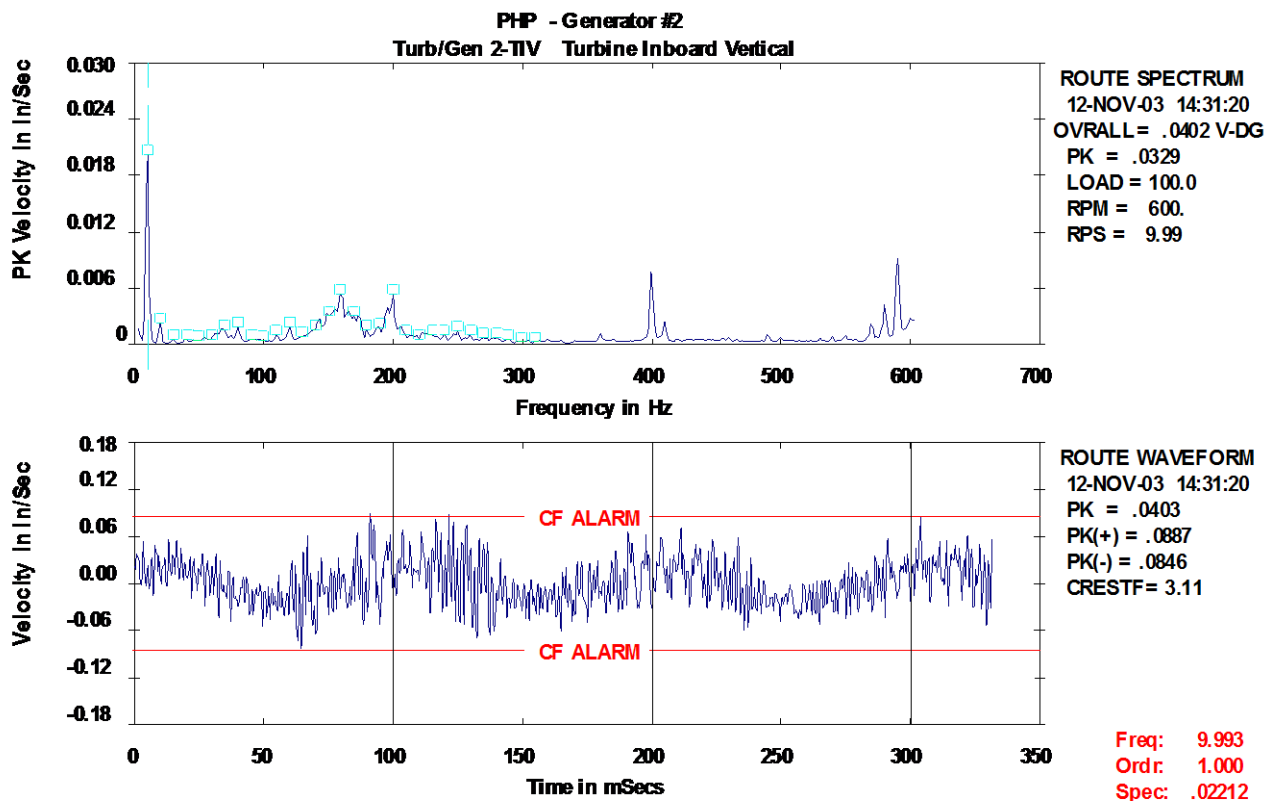
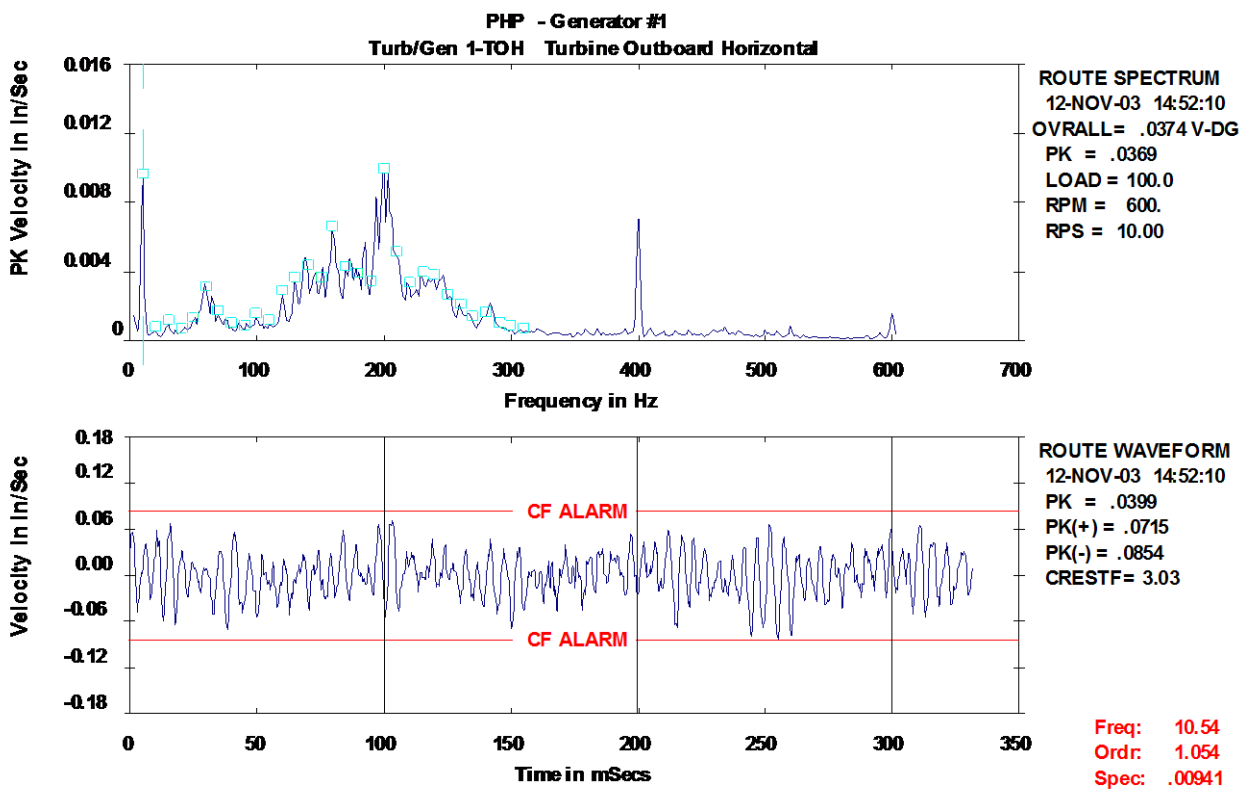
No problems in these locations other than the slight unbalance on turbine #2.

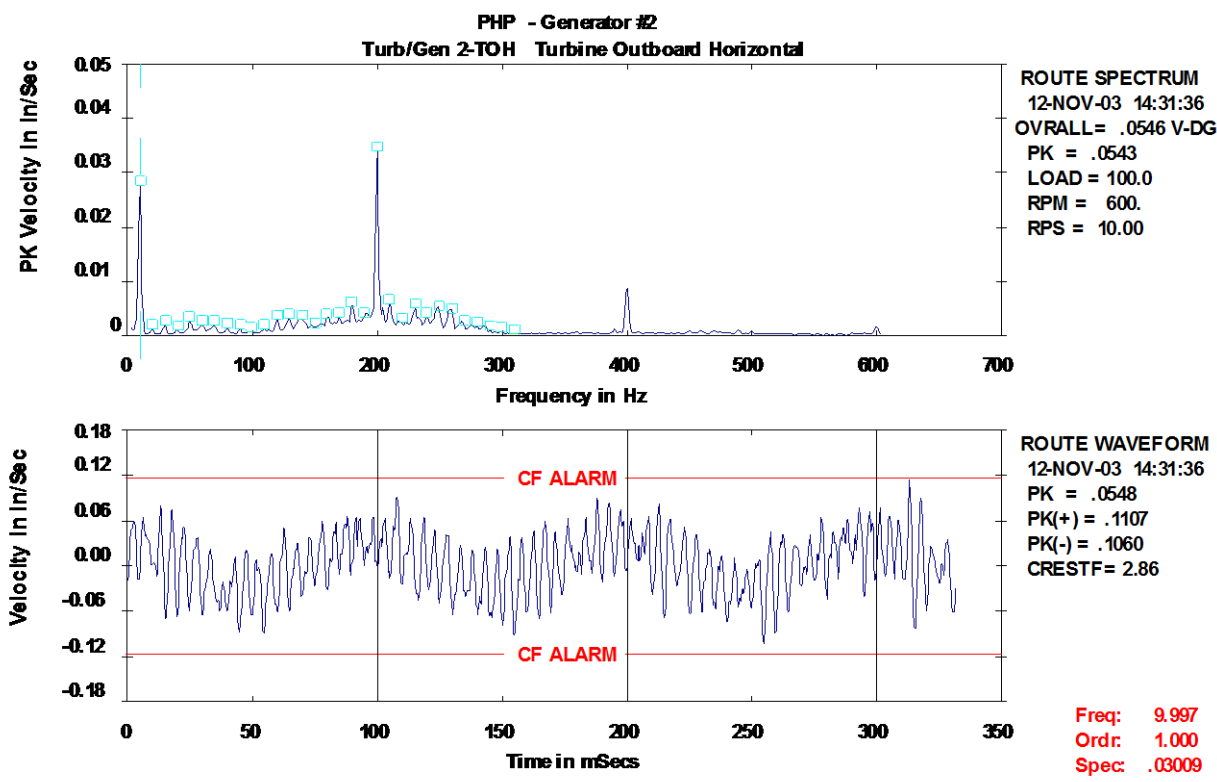
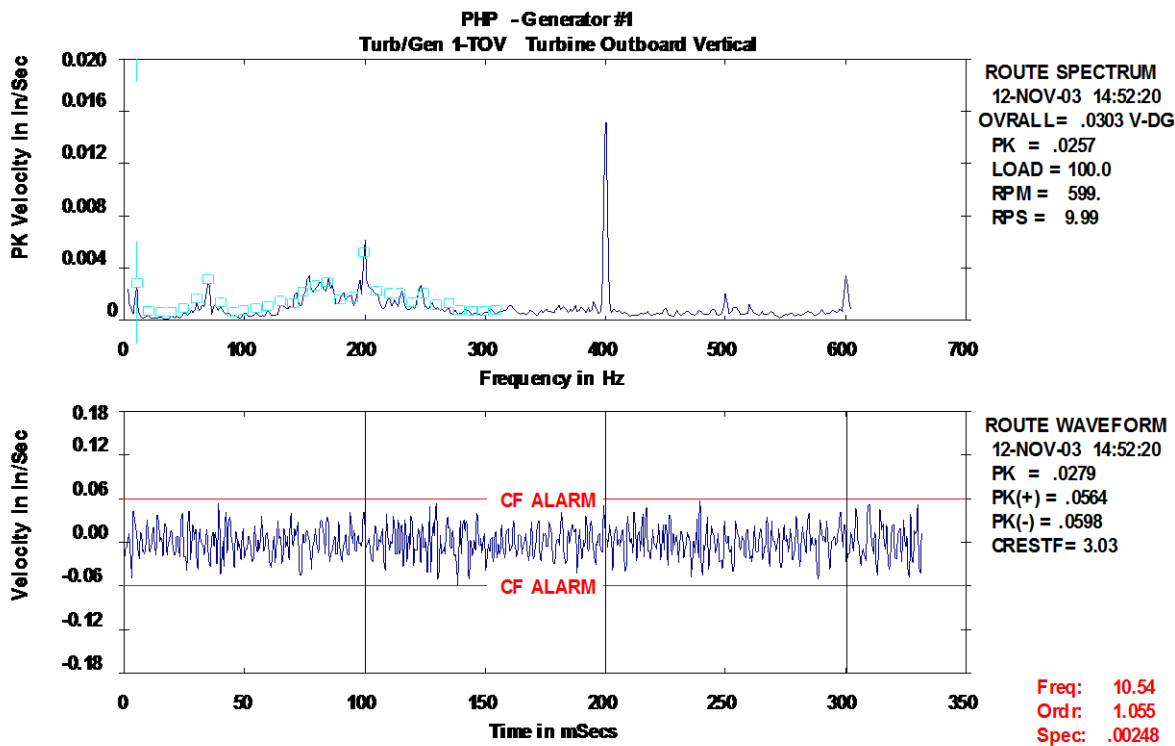
No problems apparent at these locations. The unbalance on turbine #2 noted in the horizontal plane is not as apparent in the vertical axis because of the relative stiffness in the vertical plane.

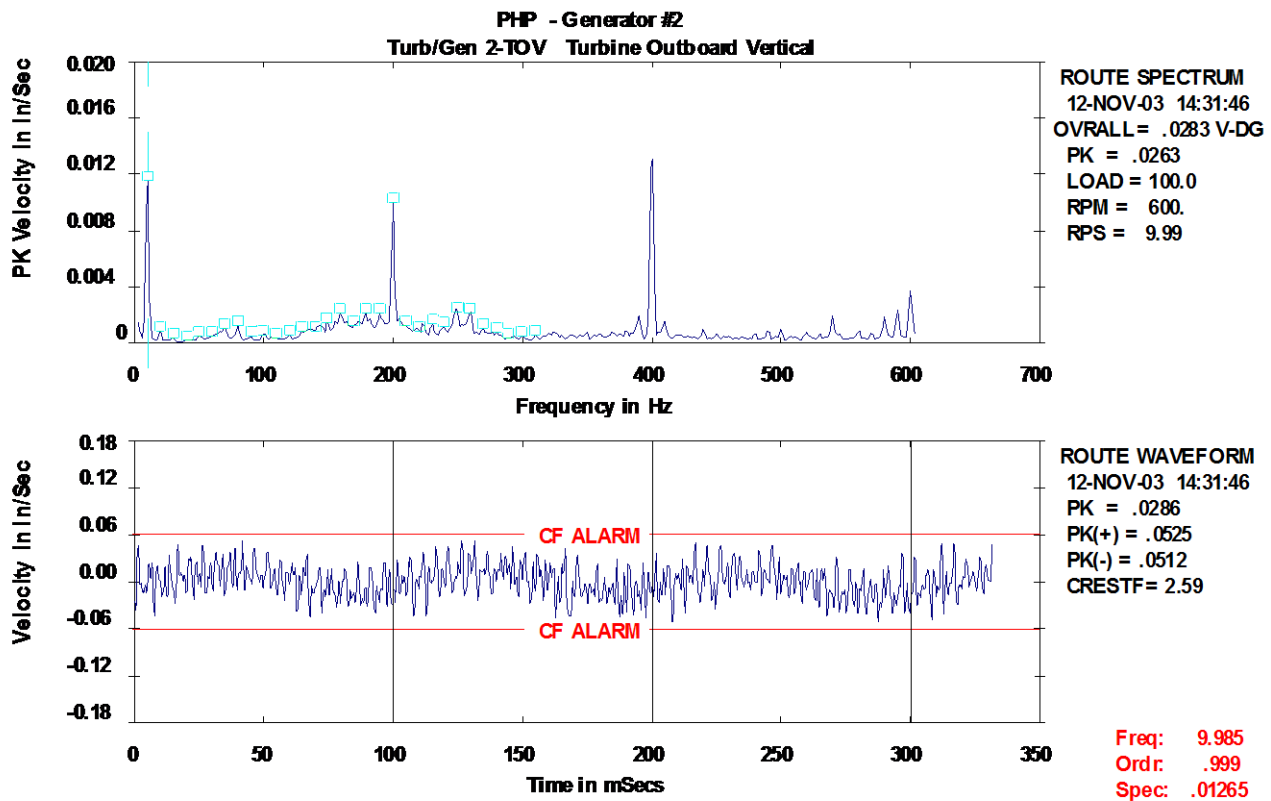
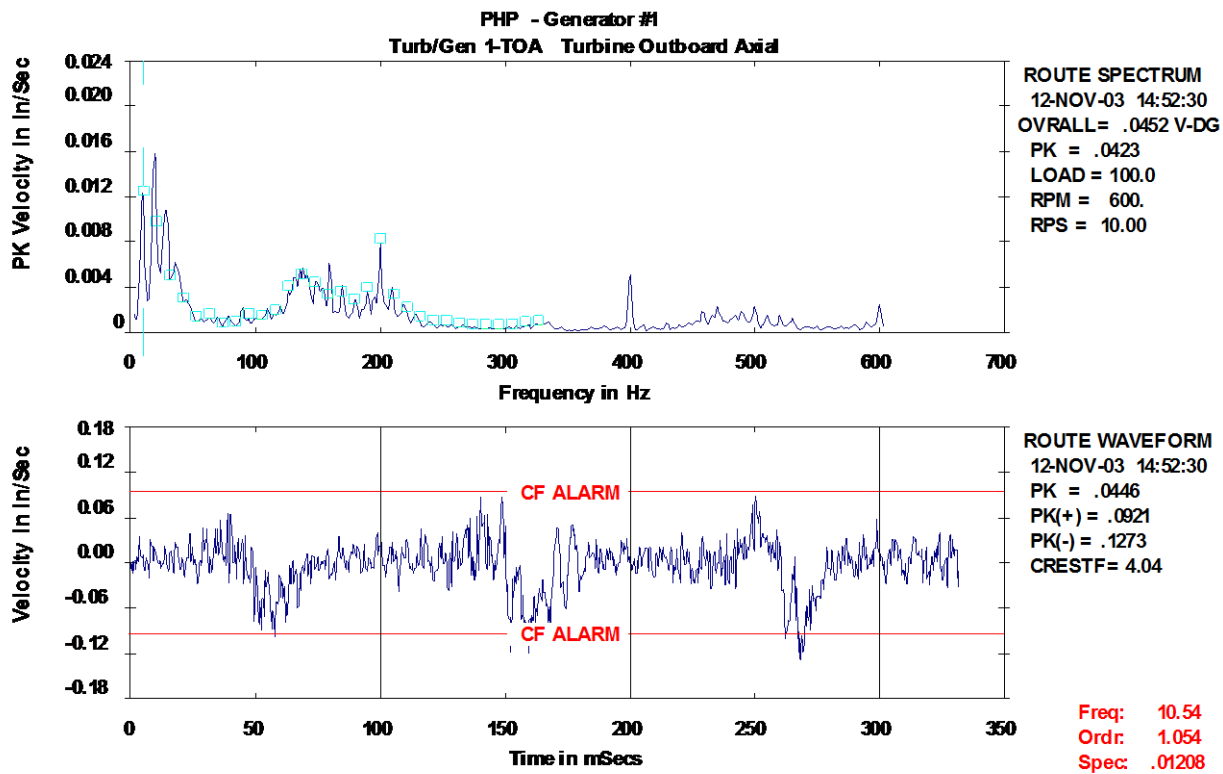
Amplitudes on both turbines are low, however the unusual waveform noted on turbine #1 could be an indication of thrust bearing problem.

The only other notable observation was turbine #1 thrust bearing, the amplitudes recorded at this location are low but have an the waveform is irregular. To give more accurate analysis both machines should be analyzed on a regular basis so that the spectral information can be trended.
