## VIBETEC INC.

14<sup>th</sup> November 2003

Ref: 15MW Hydro Generator Sets #1 and 2 at your Pingston location.  
 Generator #1: serial # 167955-1 / Generator #2: serial # 167955-2  
 Dave,

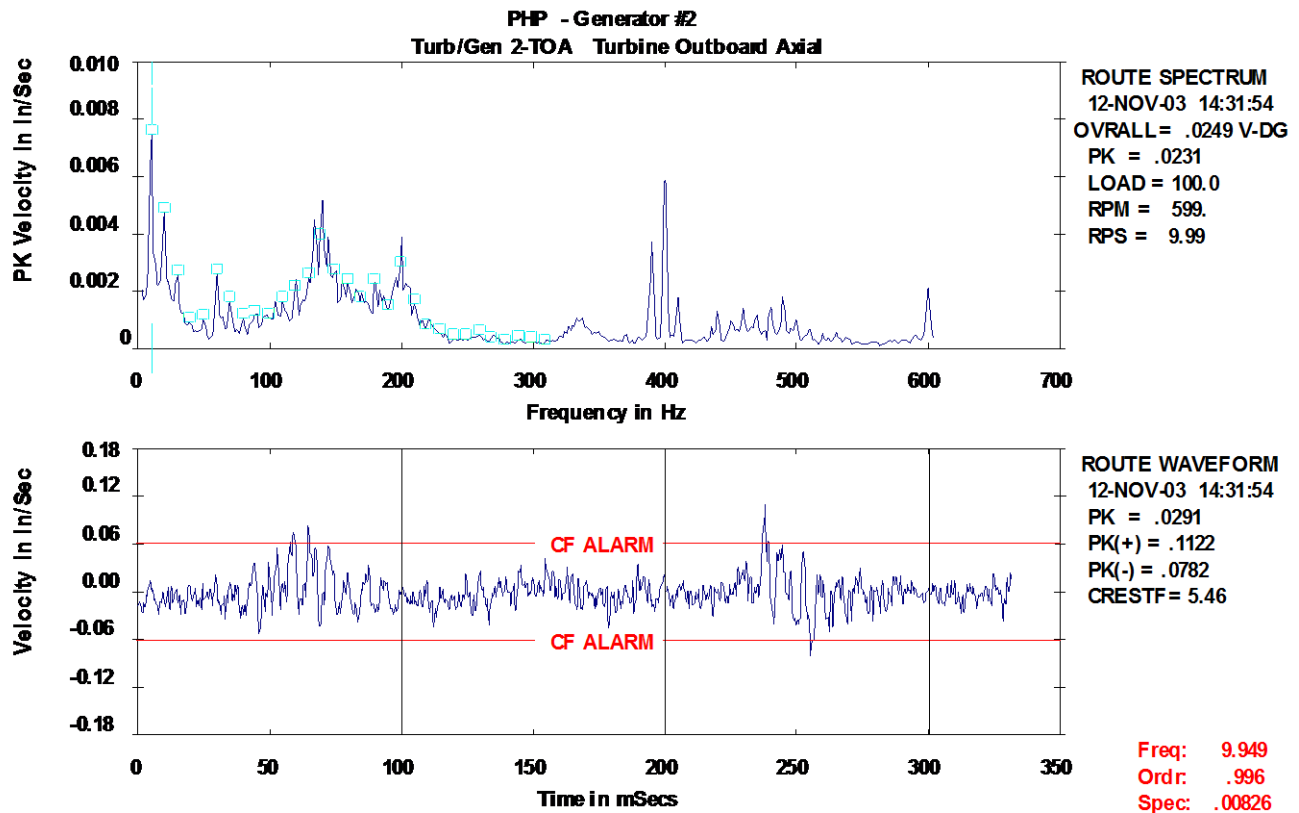
Amplitudes on both turbines are low, however the unusual waveform noted on turbine #1 could be an indication of thrust bearing problem.
